SCHEDULE OF CONDITION

*STORMONT TRUCK & VAN PREMISES*

*UNITS 2 & 3*

JULY 2001

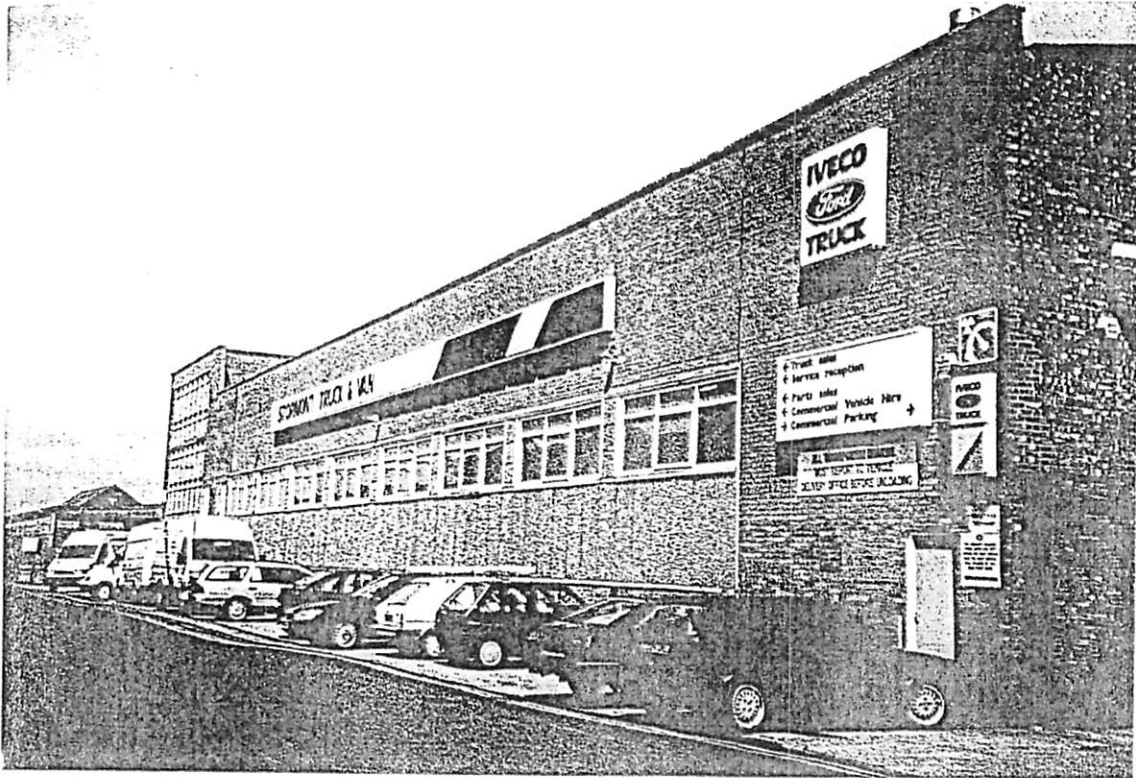
1. Unit 3 - South elevation

- 3.07.1     Facing brickwork generally weathered and worn, mortar joints missing and eroded in many areas. Previous patch repairs, non-matching in many areas.
- 3.07.2     Several stepped cracks from coping level to heads of windows. Cracks previously repaired in non-matching brickwork and mortar.

3.07.3 Stepped cracks in brickwork at low level beneath concrete infill panelling. Cracks previously repaired with non-matching brickwork and mortar.

3.07.5 Movement to elevation, particularly apparent at the east corner brickwork where overhang at damp-course level.

3.07.6 Minor displacement and cracking in concrete infill panels, some slightly out of line.

3.07.8 Lead flashings above windows split in several areas.

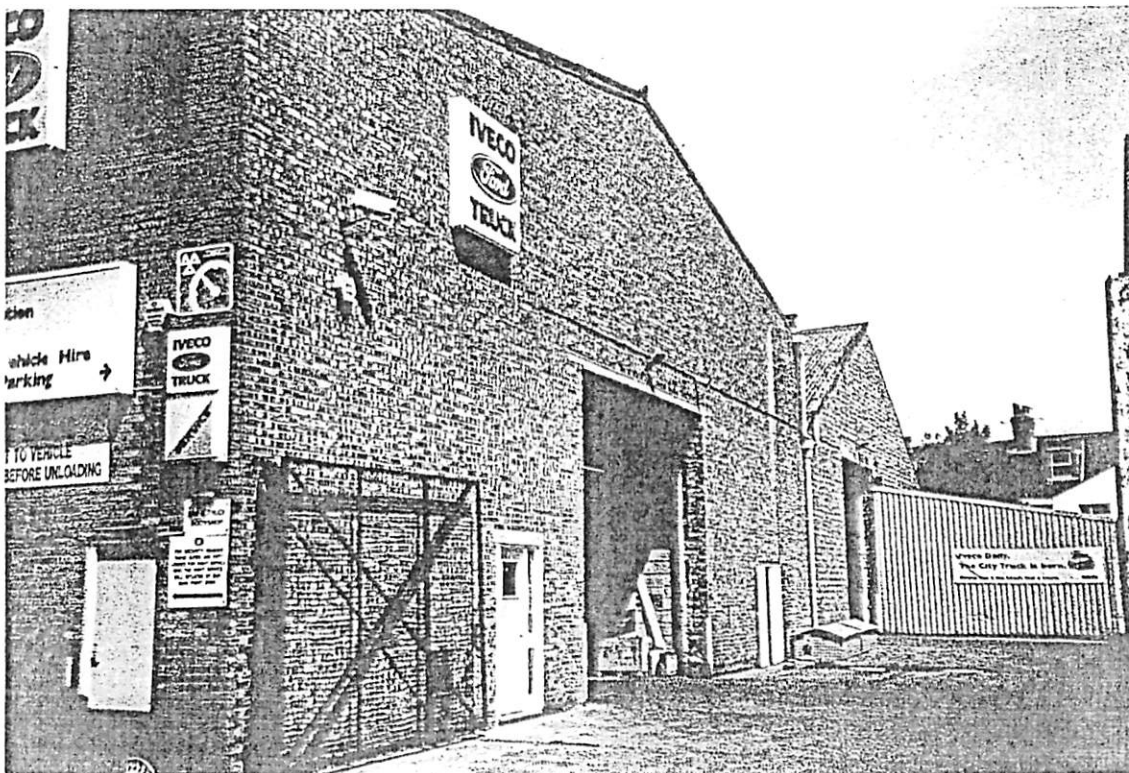
2. East Elevations, Units 3&2

3.08.1 Facing brickwork in reasonable condition, some staining and missing and eroded pointing.

3.10.1 Facing brickwork in generally reasonable condition. Some discolouration, staining and missing and eroded pointing.

3.10.2 Significant cracking and movement to north corner brickwork at low level, also apparent on north elevation.

- 3.10.3 Inset steel beam with render facing above pedestrian door level generally corroded and rendering broken and missing in many areas. Splitting to brickwork generally along the length of beam.
- 3.10.4 Concrete lintel above pedestrian door extensively spalled and reinforcing bars exposed.
- 3.10.5 Monopitch steel frame lean-to building abutting to north in reasonable condition, some impact damage to cladding.
- 3.10.6 Blockwork store abutting external wall to north Tenant responsibility under Lease.

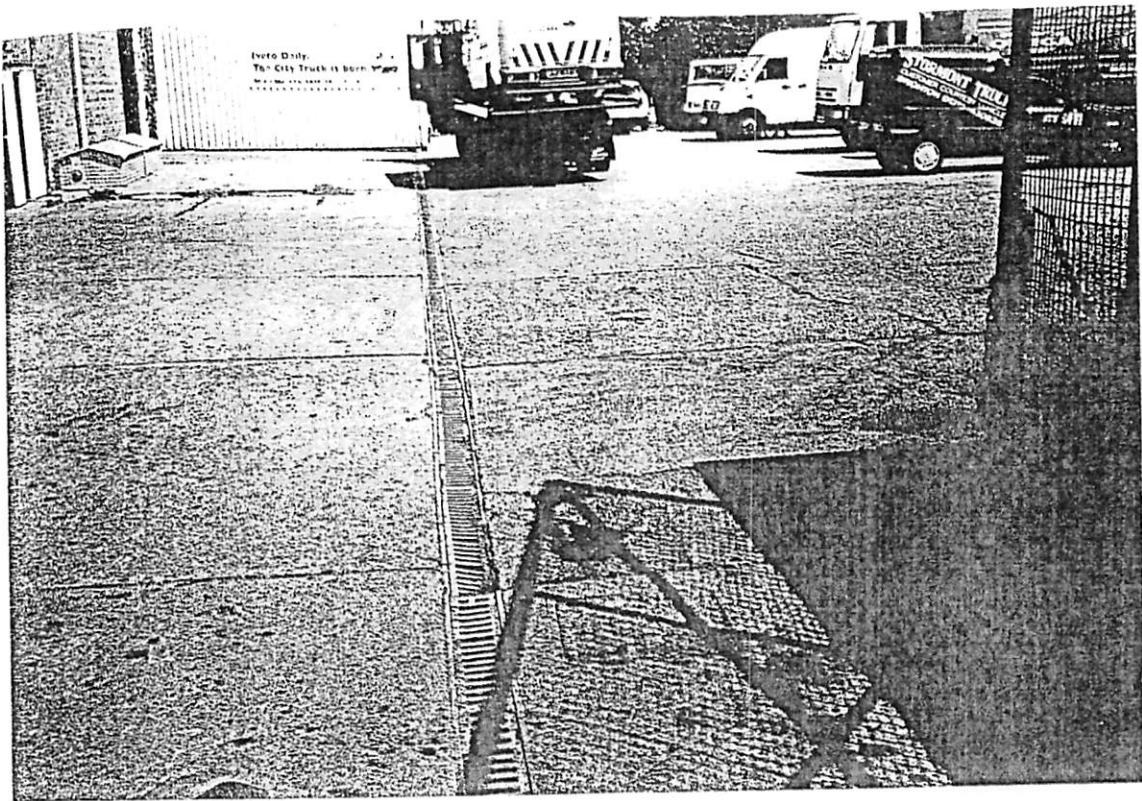
3. East Yard

- 3.01.1 In-situ concrete surfacing and cast iron drainage channels of considerable age and in poor condition. Small area of bitumen macadam to north-west corner in poor condition. ~~Specific Tenant responsibility to repair as required by Lease.~~ ⊗
- 3.01.2 ~~Perimeter chainlink fencing to perimeter in poor condition. Metal frame gates to east and south, in poor condition. [Specific Tenant responsibility to repair as required by Lease.]~~
- 3.01.3 ~~Lamp standards installed to perimeter of yard, in poor condition.~~

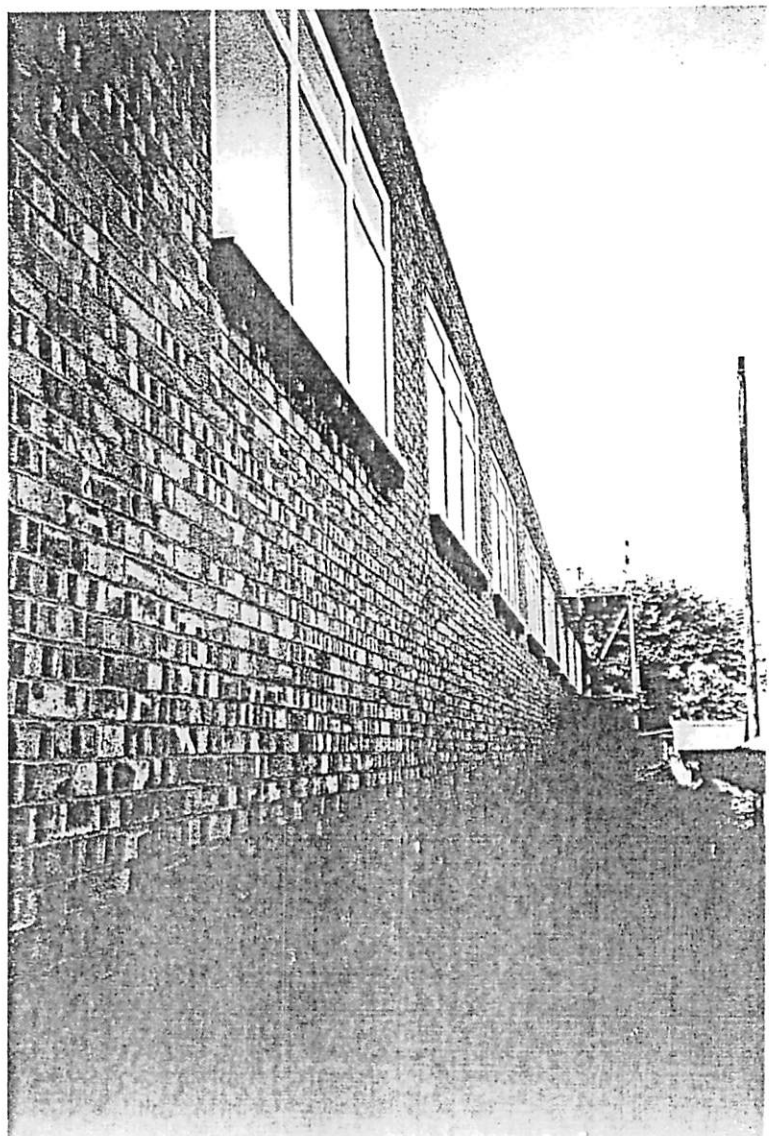
4. Unit 2 - North Elevation

- 3.11.1 Facing brickwork in reasonable condition with some areas of staining, erosion of mortar and loss of brick faces. Extensive cracking and movement to brickwork to north-east corner, previous patch repairs. Some splitting to parapet wall. Brickwork modified to east end. Small area of graffiti to west.
- 3.11.2 Rendered plinth to east corner badly cracked with loose sections of render finish, plant growth from finishes. Section missing on corner.
- 3.11.3 Parapet wall of half-brick construction, generally poor detail and uneven finish. Exposed section of asbestos cement gutter to east end broken on outer edges. Flashings at parapet abutment generally deteriorated and patch repaired.

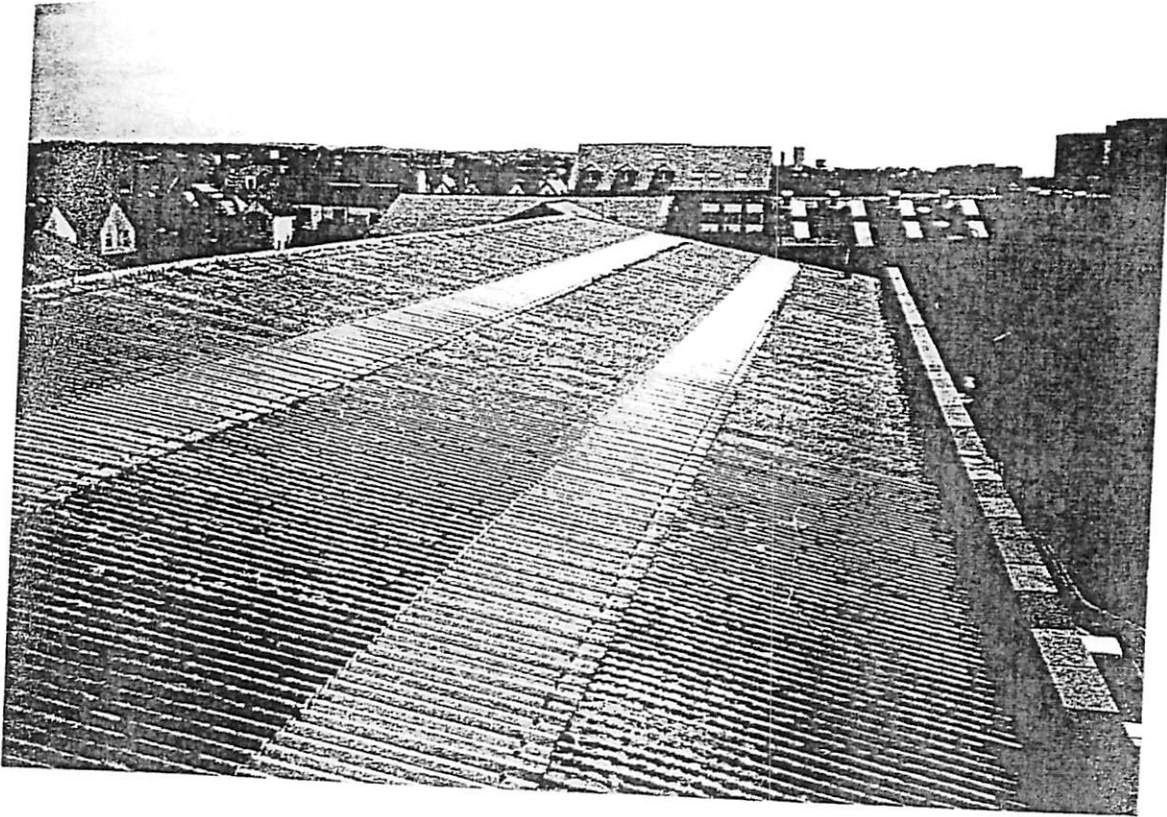
5. Unit 3 - South roof slope

- 3.03.1     Asbestos cement corrugated sheeting of considerable age, generally deteriorated and fixings corroded. All translucent glass fibre rooflights discoloured and surfaces deteriorated.
- 3.03.2     Lead flashings at abutment with south parapet wall in poor condition, split in several areas. Inner brickwork to parapet spalled and deteriorated. Concrete copings worn and some areas spalled, joints deteriorated and missing.
- 3.03.3     West asbestos cement bargeboard broken, poor flashing detail at abutment with office parapet wall. Bargeboards and ridges generally discoloured and weathered, fixings corroded.

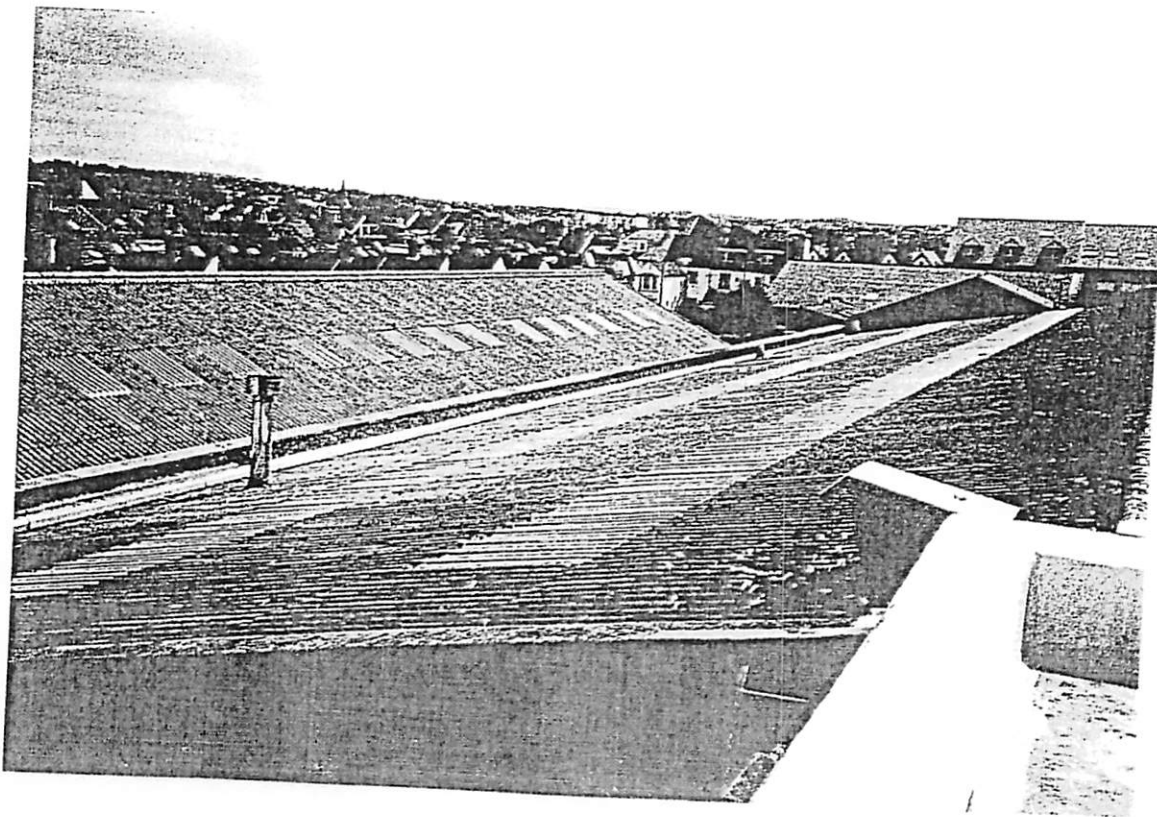
6. Unit 3 - North roof slope/Unit 2 - South roof slope

3.09.1 Asbestos cement corrugated sheeting and components of considerable age and generally deteriorated. Fixings to sheets generally corroded and several loose/missing. Some sheet edges broken at south gutter abutment. Filler sections dislodged from bottom of roof sheets in several areas.

3.09.2 1No. depressed glassfibre rooflight to bottom row on south slope.

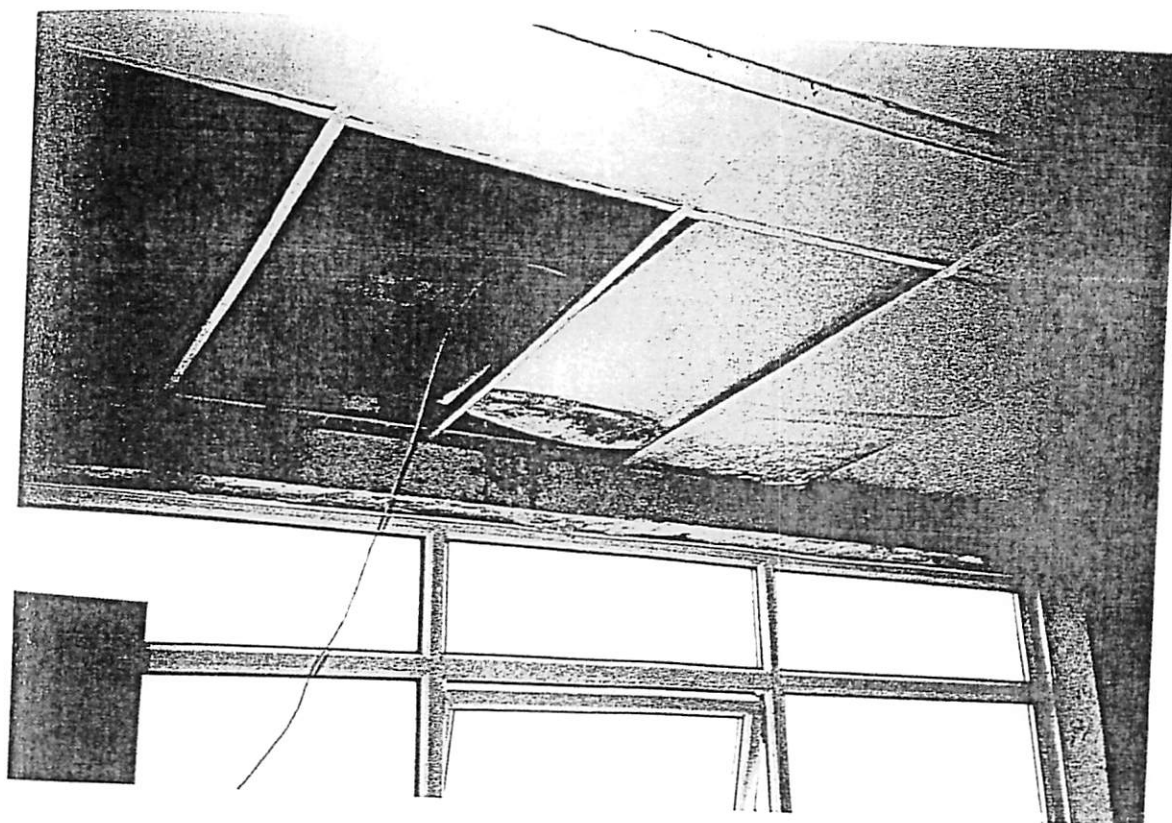
7. Unit 3 - Canteen ceiling

- 4.01.1 Suspended ceilings to Canteen, store and WC areas on east mezzanine floor generally in poor condition, extensive water damage under roof gutters. Some ceiling tiles missing, grid damaged in several areas.
- 4.01.2 Asbestos fire protection to upper sections of steel stanchions and cross braces. Asbestos damaged to cross brace in west corner adjacent to storage area.

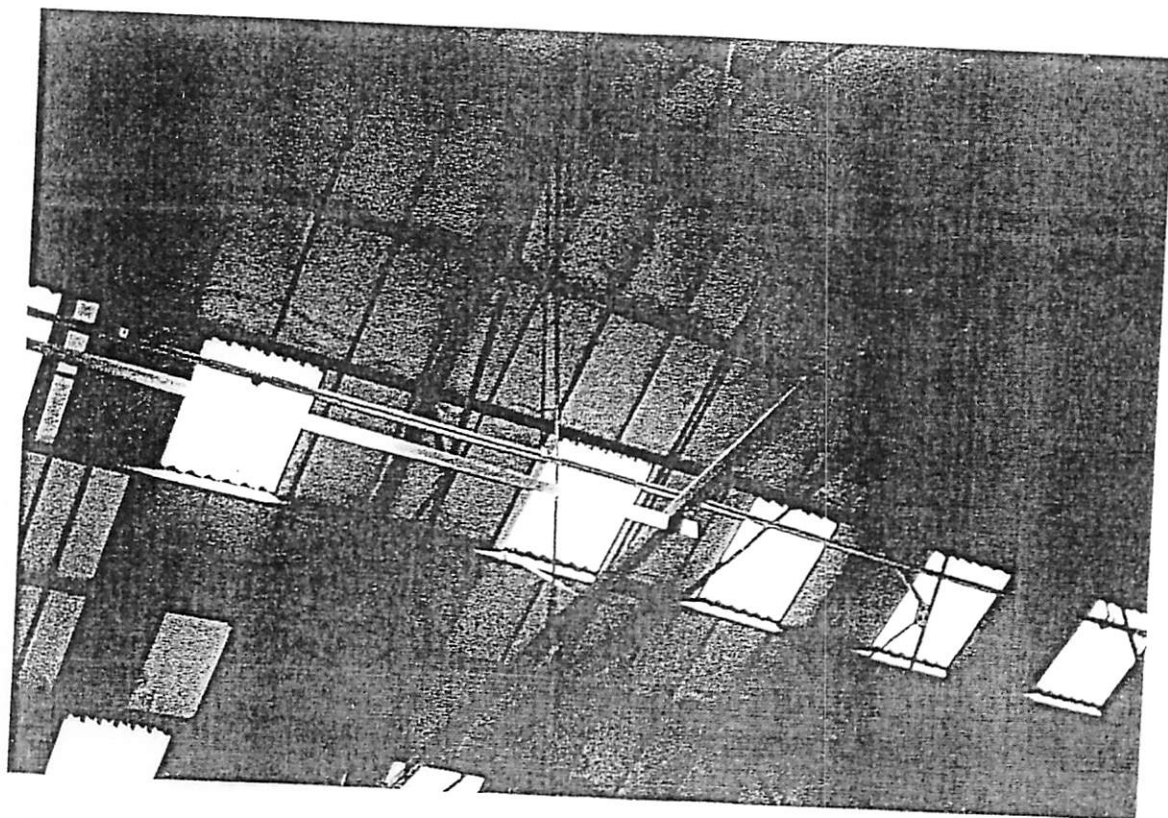
8. Unit 2 - Ceiling linings

- 4.02.1     Roof underlining panels set in metal grid, extensively water damaged and stained. Some areas of grid damaged to west. Several underlining panels replaced and non-matching, small holes in panels in some areas. Some panels dislodged.
- 4.02.2     Extensive water leakage and damage to finishes to north-east corner walls.
- 4.02.3     Significant horizontal cracking to east external wall where corrosion of steel beam has occurred.
- 4.02.4     Significant cracking to north-east corner brickwork at low level, in line with cracking externally.
