CEC Blatchington Road, Brighton

Structural Feasibility Report

May 2024

Client Name: CO-OP GROUP
Document Reference: STR19319-WAT-ZZ-ZZZ-RP-S-001
Project Number: STR19319

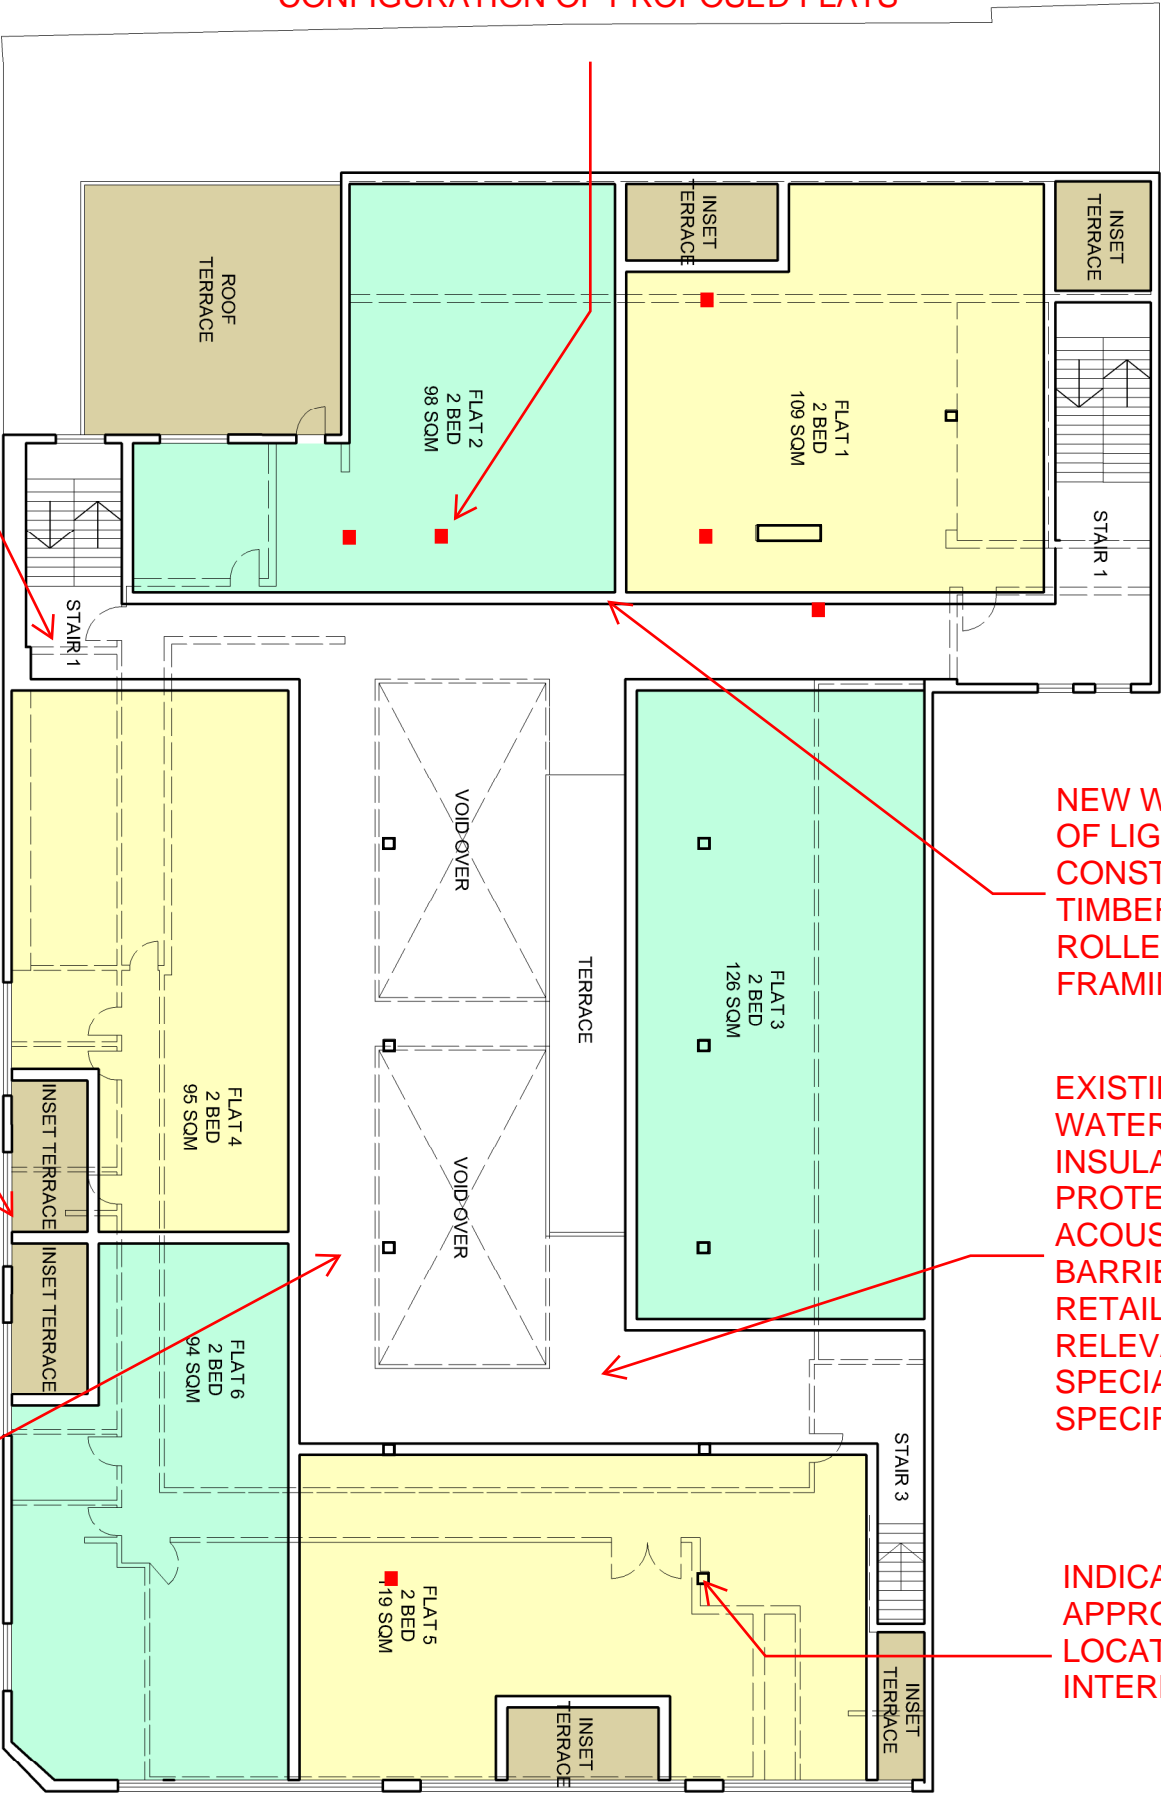
NEW WALLS TO BE OF LIGHTWEIGHT CONSTRUCTION I.E. TIMBER OR COLD ROLLED SFS FRAMING SYSTEM

EXISTING FLOOR TO BE WATERPROOFED, INSULATED, FIRE PROTECTED AND ACOUSTICALLY BARRIERED FROM THE RETAIL FLOOR BELOW RELEVANT SPECIALISTS SPECIFICATIONS

PROPOSED FLOOR PLAN DOES NOT TAKE INTO ACCOUNT ALL INTERNAL COLUMNS. REFER TO WSL SITE SURVEY SKETCH FOR APPROXIMATE LOCATIONS. LOCATION OF COLUMNS WILL AFFECT CONFIGURATION OF PROPOSED FLATS

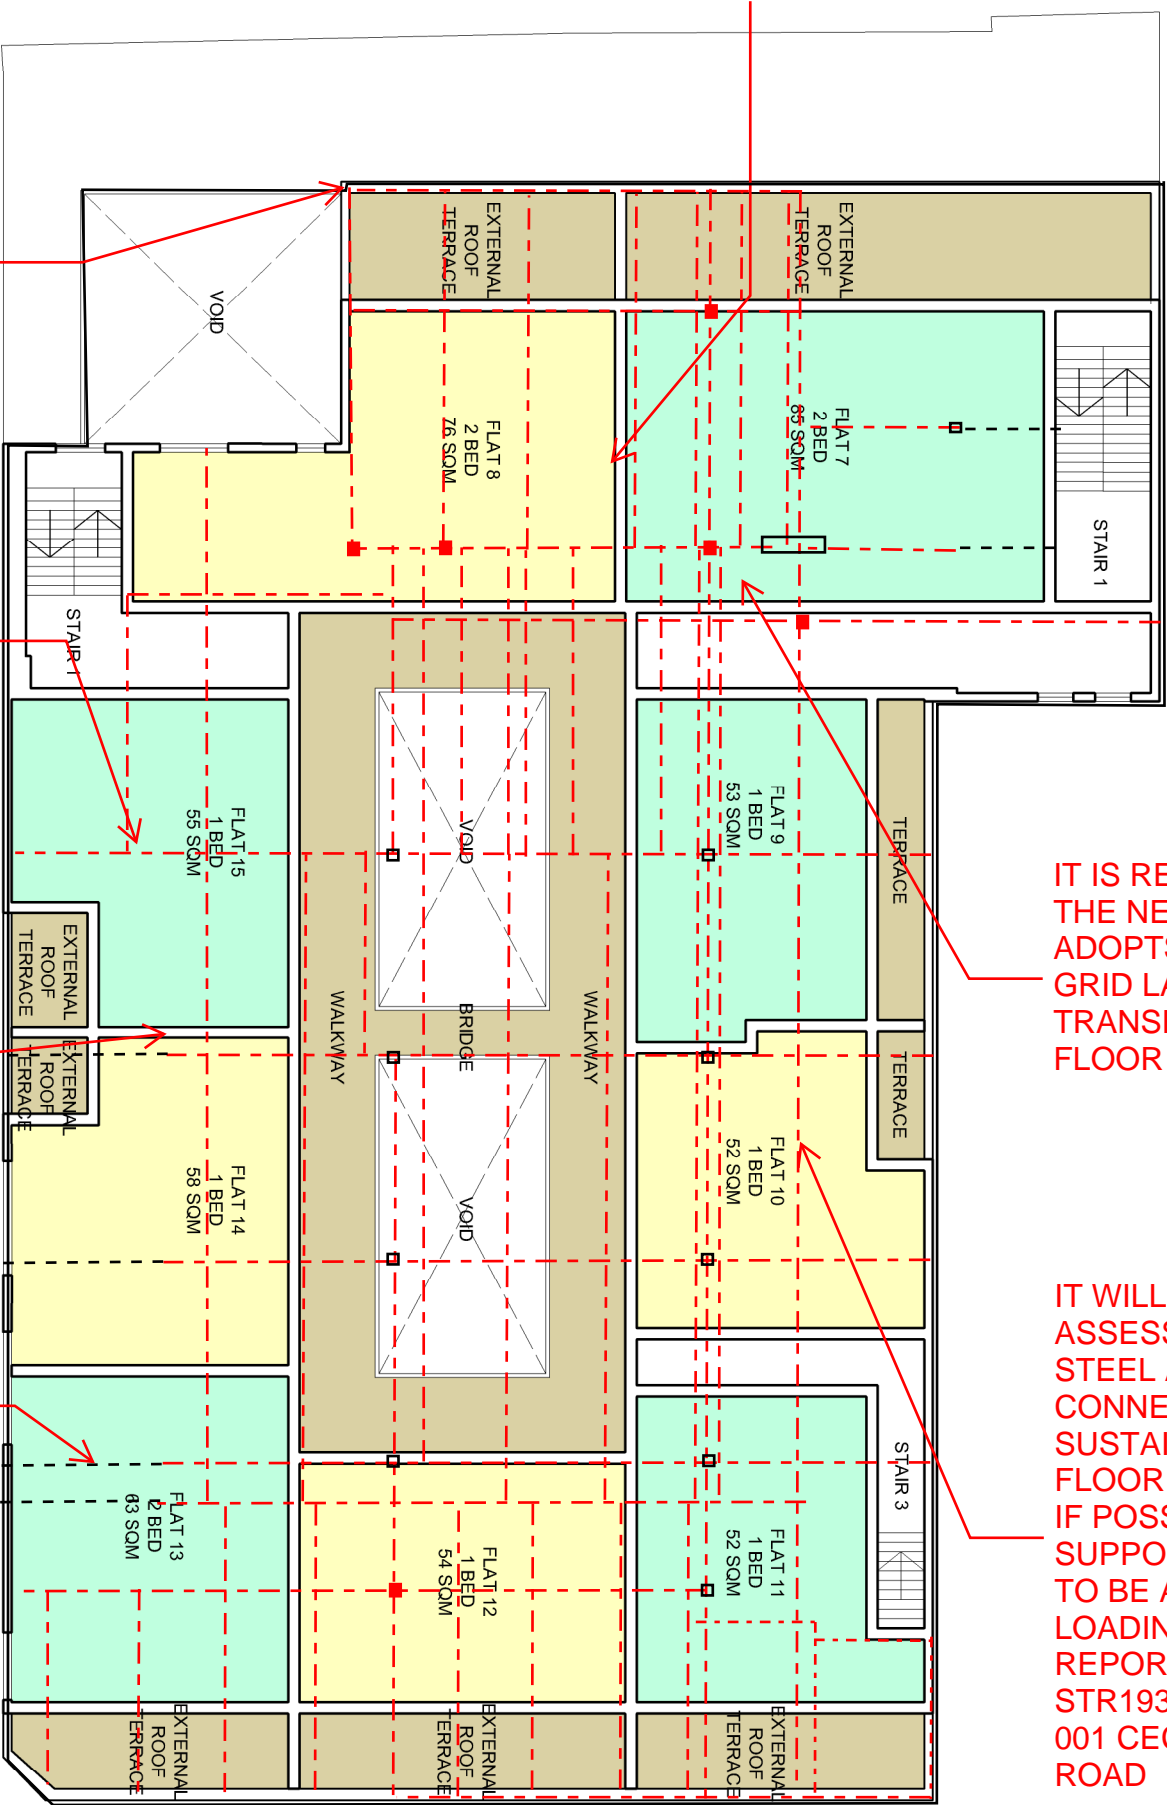
IT IS RECOMMENDED THAT THE NEW SECOND FLOOR ADOPTS THE SAME COLUMN GRID LAYOUT TO AVOID TRANSFER BEAMS ON FLOOR BELOW

IT WILL BE PRUDENT TO ASSESS WHETHER EXISTING STEEL AND STEEL CONNECTIONS COULD SUSTAIN NEW SECOND FLOOR LOAD AND RETAINED IF POSSIBLE. EXISTING SUPPORTING STRUCTURE TO BE ASSESSED FOR NEW LOADING - REFER TO WSL REPORT REFERENCED STR19319-WAT-ZZ-ZZZ-RP-S-001 CEC BLATCHINGTON ROAD

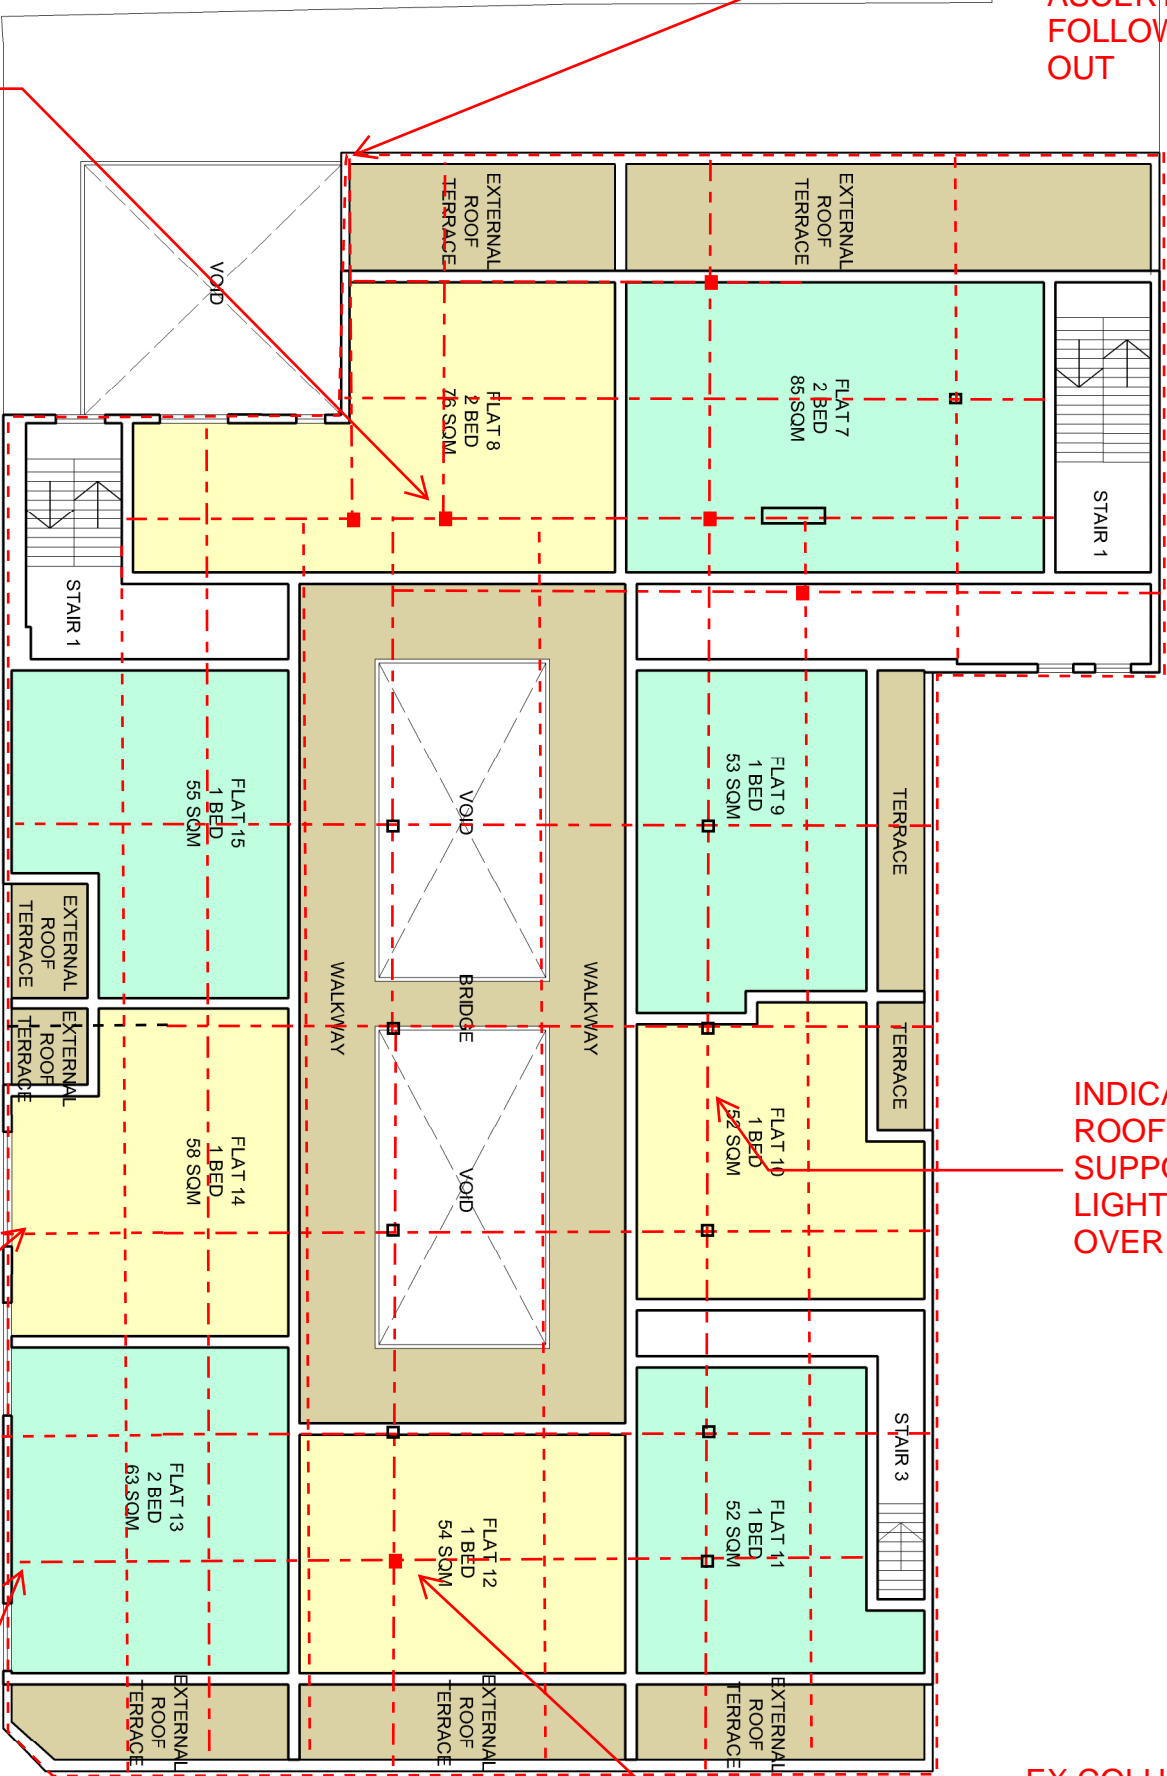
INDICATIVE STEEL GA AT ROOF LEVEL TO SUPPORT NEW LIGHTWEIGHT ROOF OVER SECOND FLOOR

EX COLUMNS EXTENDED TO ACCOMMODATE NEW SECOND FLOOR

IT IS RECOMMENDED THAT THE NEW SECOND FLOOR ADOPTS THE SAME COLUMN GRID LAYOUT TO AVOID TRANSFER BEAMS ON FLOOR BELOW AND THE NEW ROOF SUPPORTED ON STEELS ON COLUMNS EXTENDED FROM THE FIRST FLOOR SUBJECT TO FURTHER ASSESSMENT

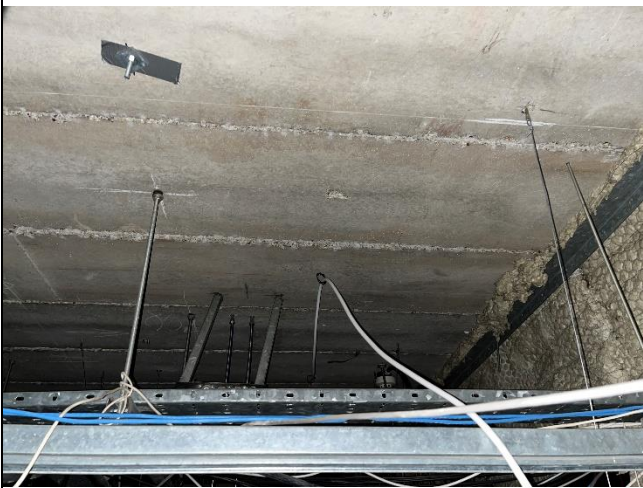
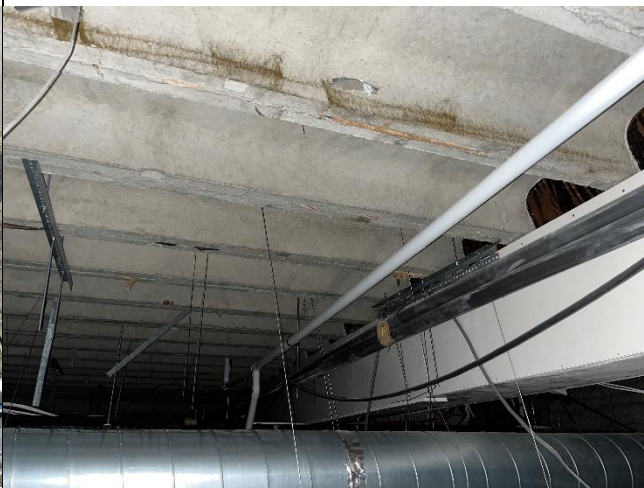
- Ground floor level appears to be consistent throughout the retail and back of house areas.
- Suspended ceiling has been adopted throughout the retail area and back of house offices. All other areas are exposed showing the soffit of the precast concrete floor.

Figure 003: Ground floor retail area soffit	Figure 004: Ground floor retail area soffit

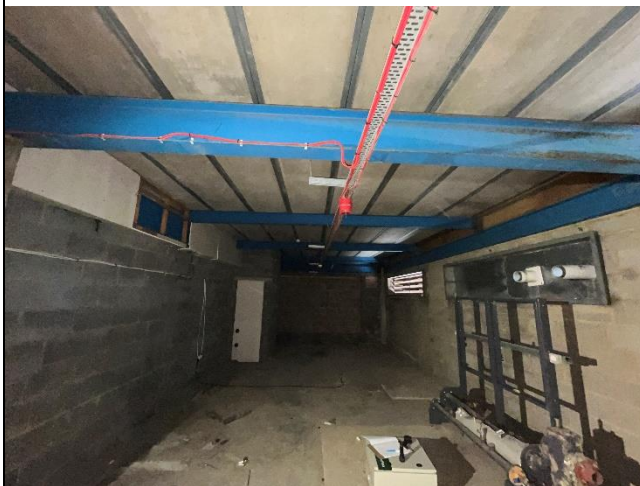
- A part of the first floor was understood to have been used as a fitness studio.
- Cracking to masonry within the first floor was observed in several location.

Figure 021: First floor stair core showing masonry cracking	Figure 022: First floor stair core

- The walls appeared to be reasonably sound, but demolition can disturb masonry and allowance should be made for localised repairs or temporary restraint during the works.

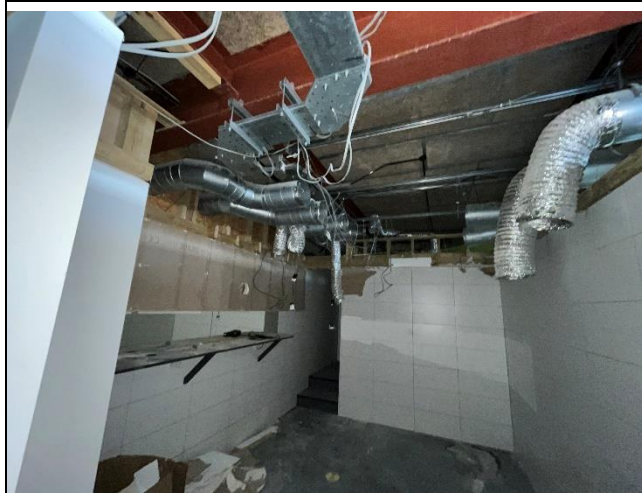
Figure 027: First floor office boiler room showing cracks to masonry

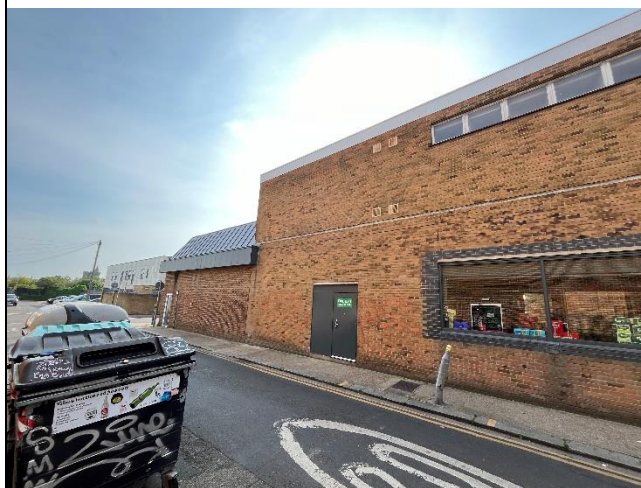
- There is minor cracking to the masonry on the external staircase to the rear of the store.
- Water staining to the masonry elevation near the eaves of the mansard standing seam roof was observed.

Figure 037: External rear elevation cracking to masonry
